TECHNICAL REPORT HL-81-II

BREAKWATER AND REVETMENT STABILITY STUDY, SAN JUAN NATIONAL HISTORIC SITE SAN JUAN, PUERTO RICO

Hydraulic Model Investigation

September 1981

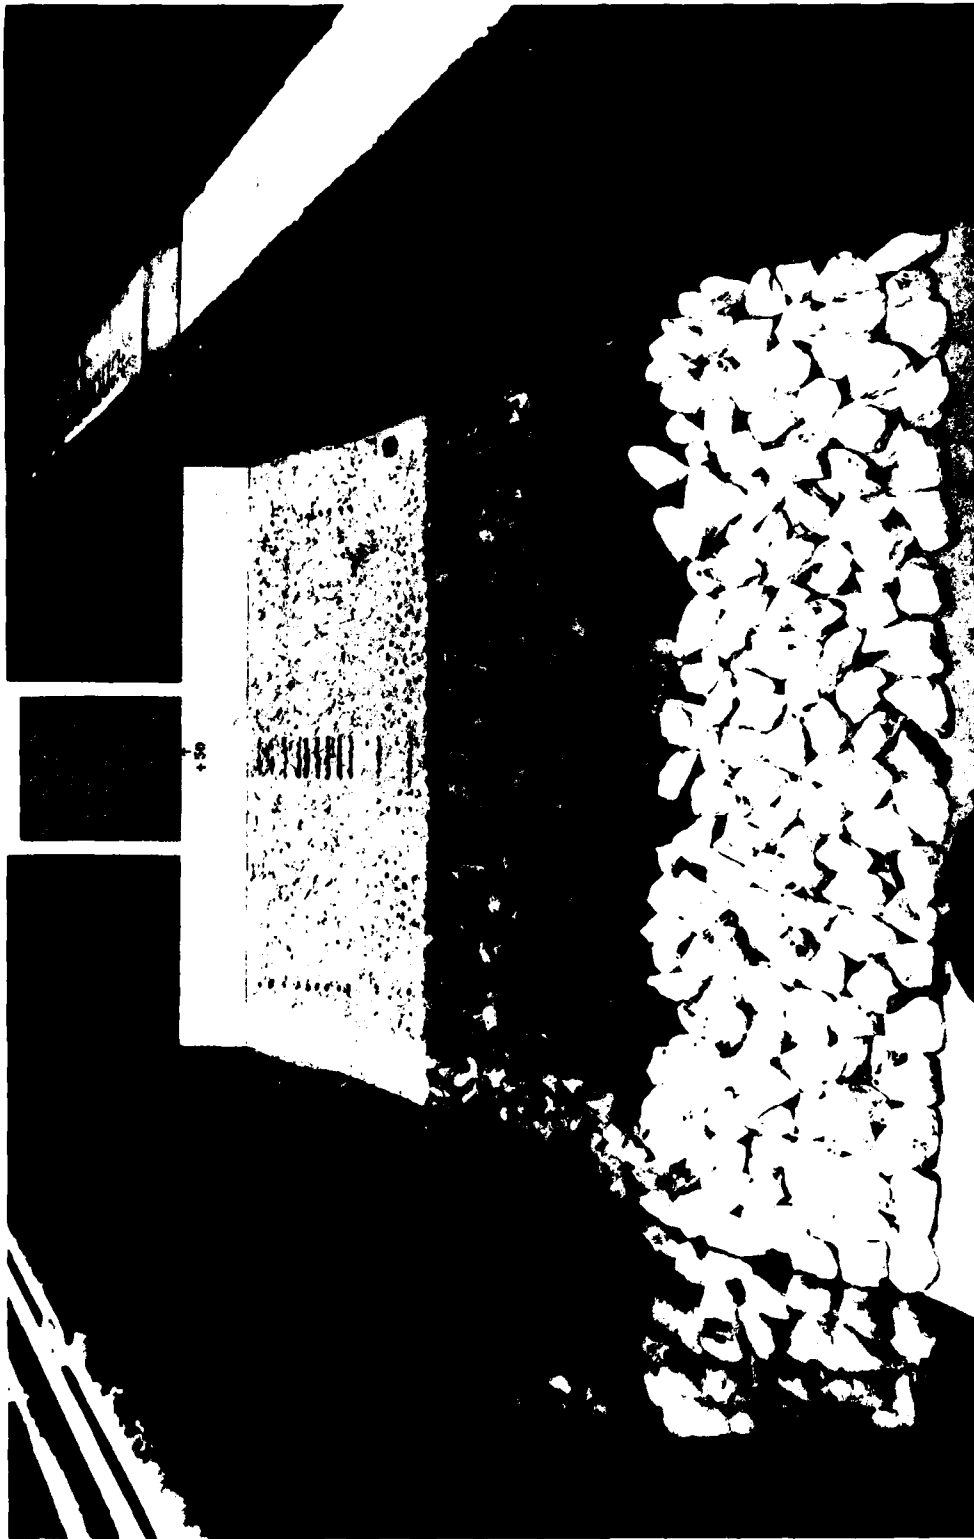
Photo 39. Sea-side view of Plan N-3 after testing Hydrograph A (Plate 1 and Table 1), 2nd test section

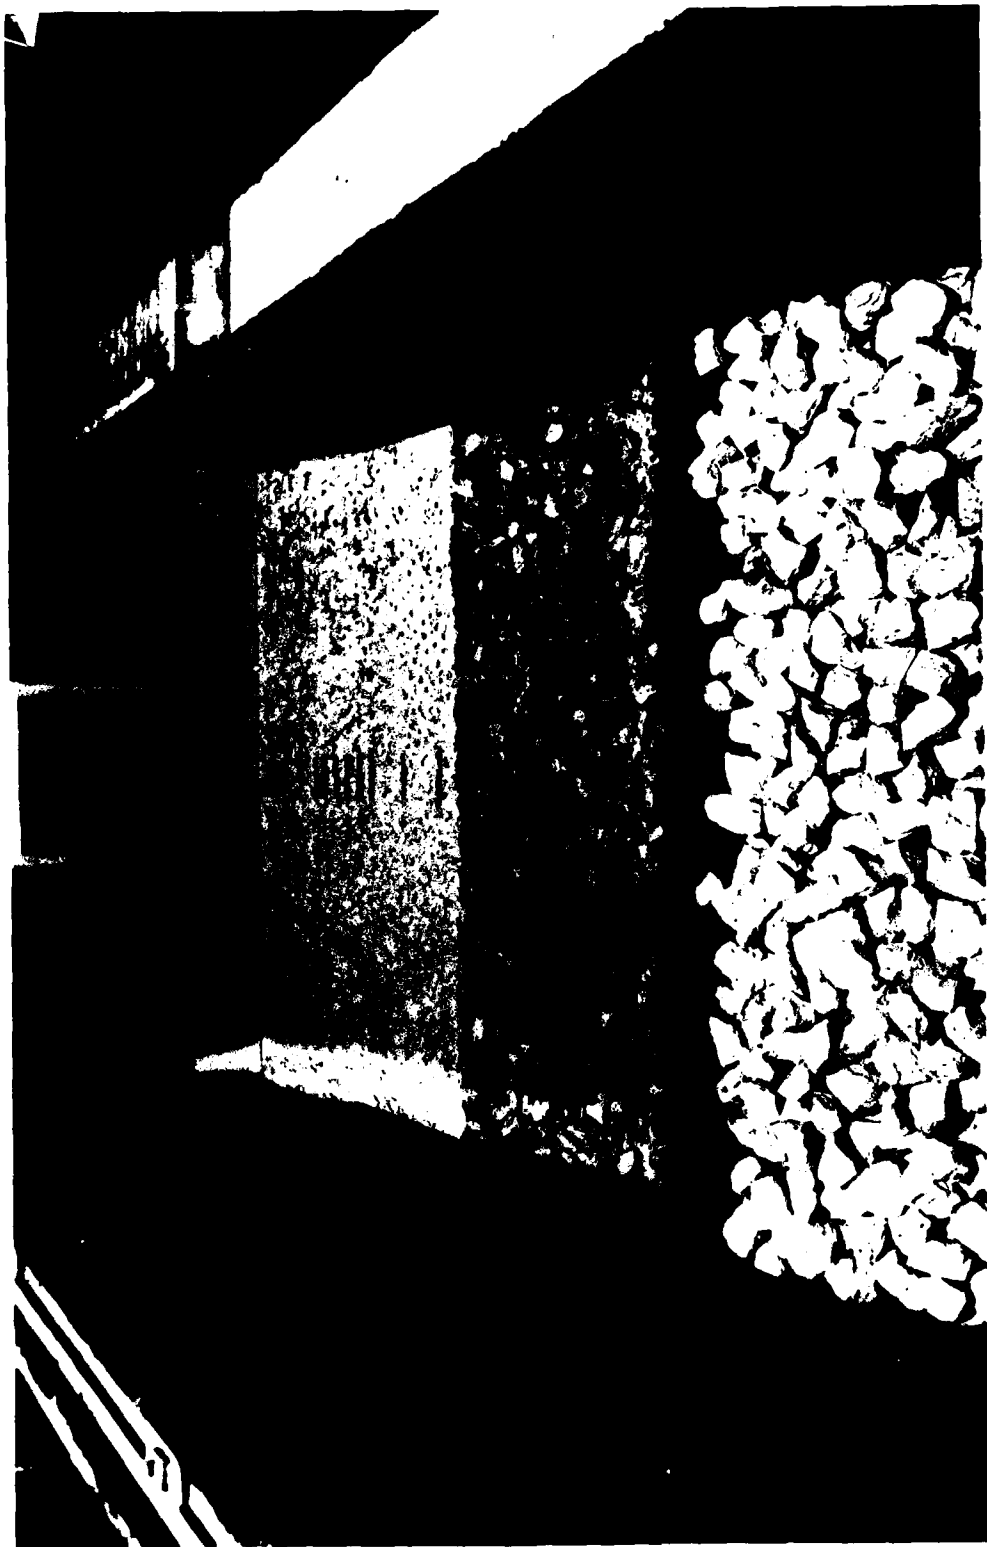
Photo 41. Sea-side view of Plan N-3-A before testing, 1st test section

33. Plan N-3-A. Tests were initiated on Plan N-3-A (Plate 8 and Photos 40 and 41) to optimize the design of Plan N-3. Plan N-3-A was identical to Plan N-3 except for the breakwater's beach-side slope below the -6.0 elevation. The two layers of 55,500-lb armor stone used in this area on Plan N-3 were replaced with 9,360-lb armor stone. Like Plan N-3, Plan N-3-A accrued minor to moderate damage to the breakwater

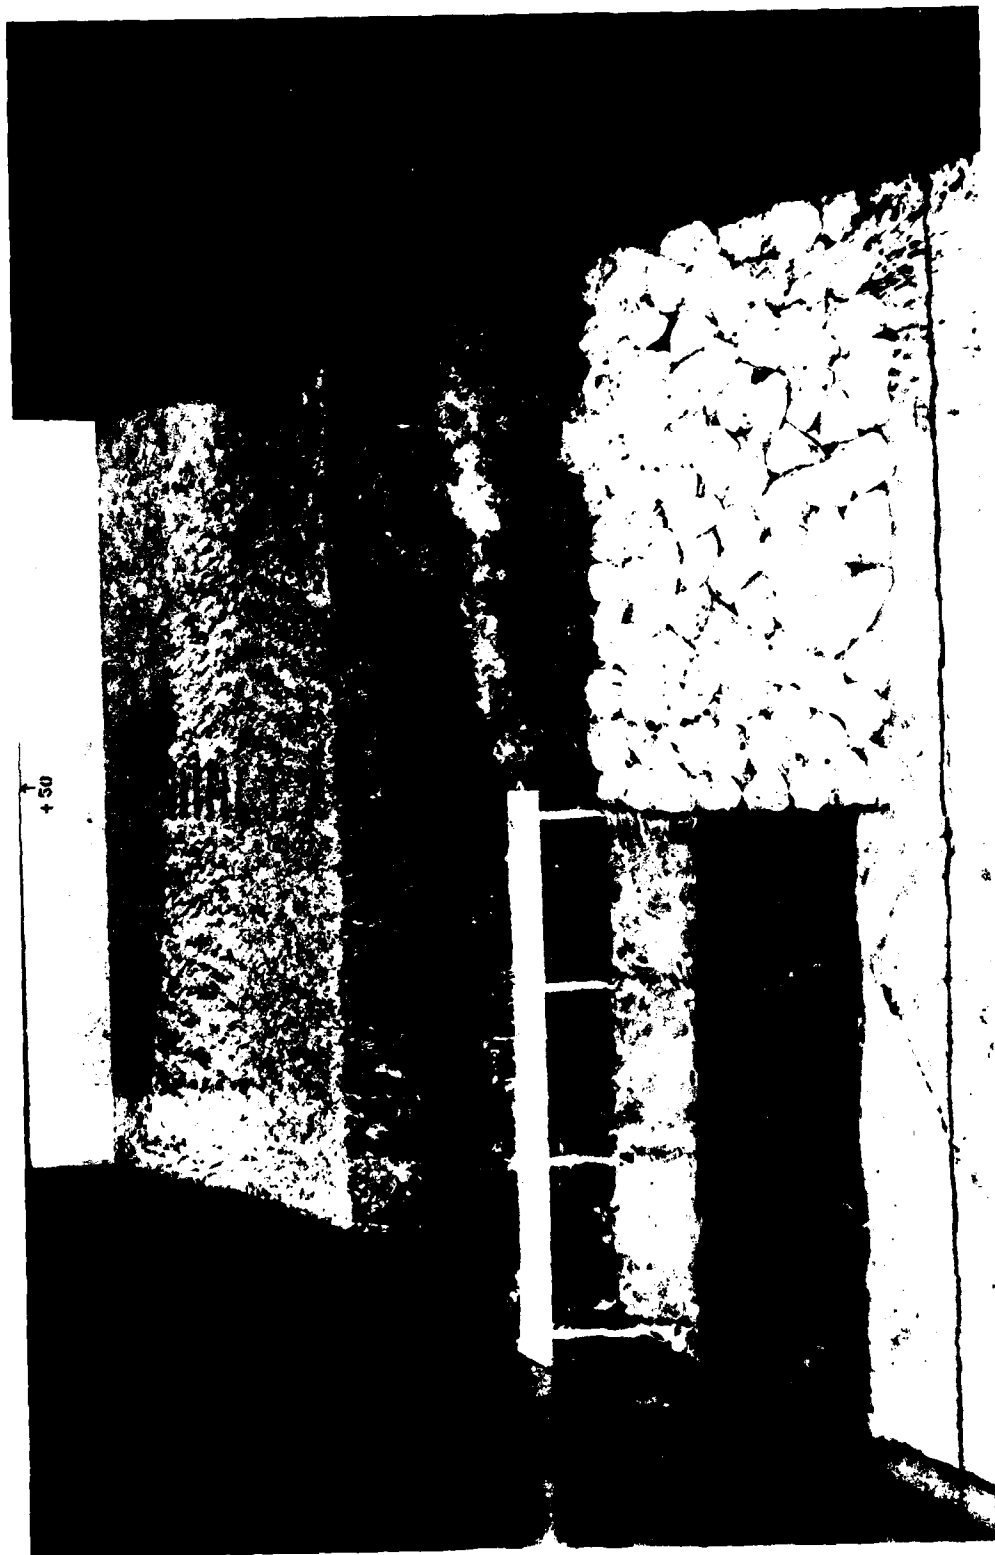
Photo 65. Sea-side view of Plan N-3-A with trestle on north slope, 11.0-sec,
15.0-ft wave at +1.9 swl

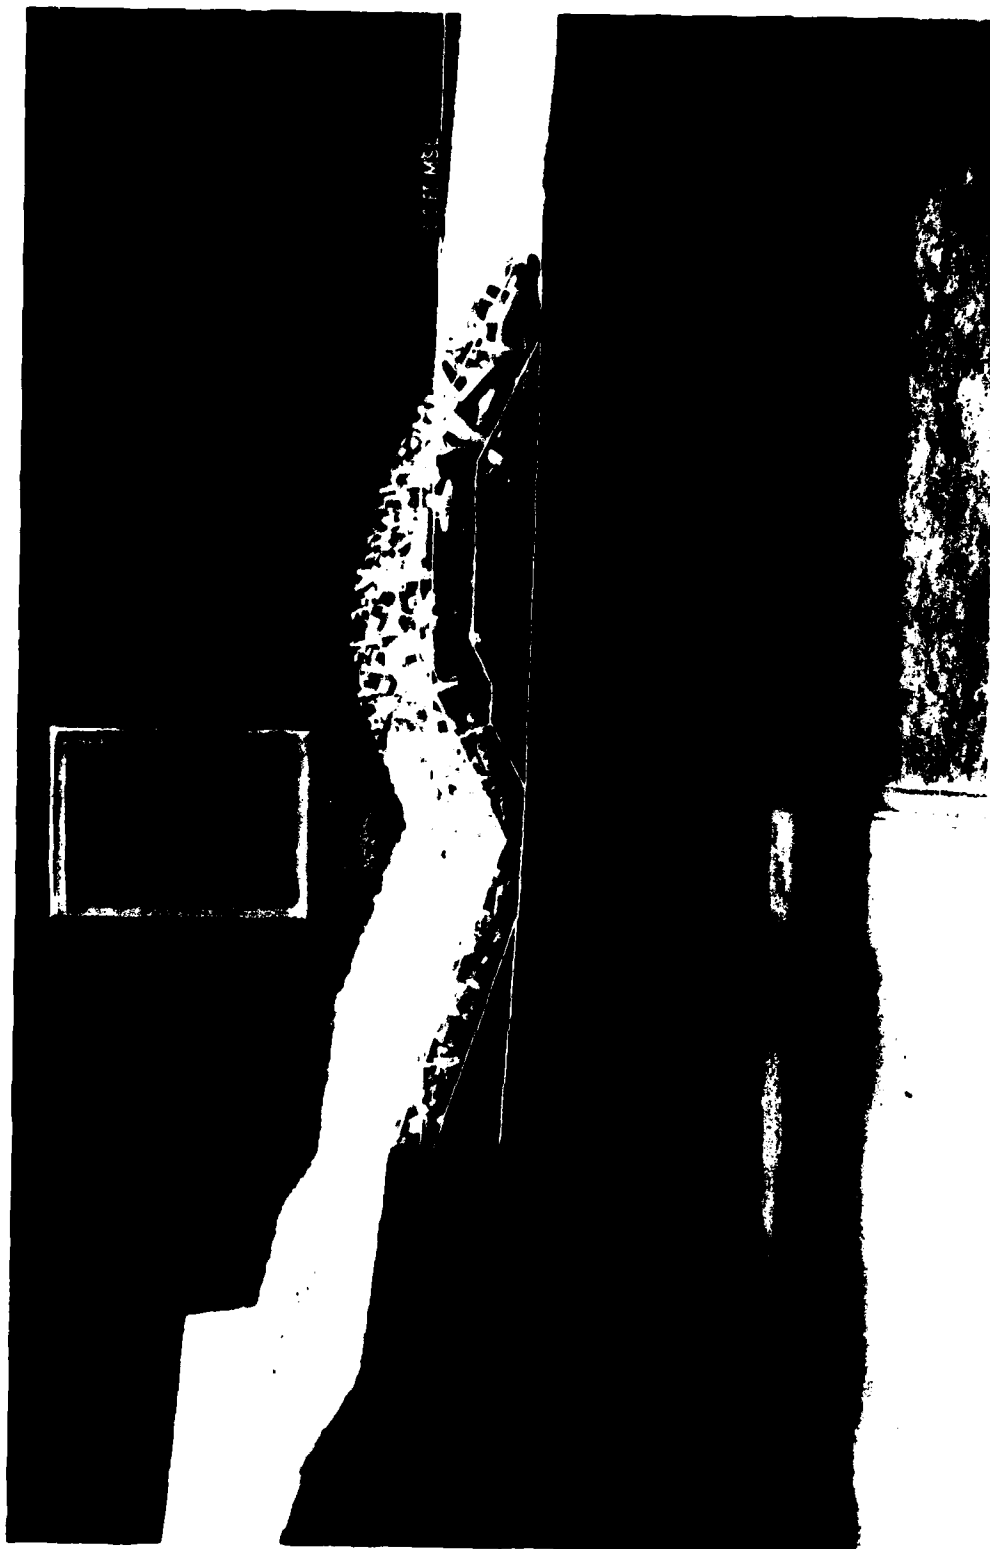
Photo 78. Side view of Plan N-6 before testing, 1st test section

40. Plan N-6. In an effort to find a stable dolos armor design for the offshore breakwater, tests were conducted on Plan N-6 (Plate 11 and Photos 78 and 79). Plan N-6 was identical to Plan N-5 except for the dolos armor and core weights which were increased to 21,830 and 4,366 lb, respectively. After exposure to Hydrograph A, the offshore breakwater's dolos armor showed moderate damage on the crown and beach-side slope with a total of seven dolosse having been displaced onto the revetment armor stone. The breakwater's sea-side slope and the revetment armor stone had accrued only minor damage. All damage on the structure had subsided by the end of the test and the condition of the structure can be seen in Photos 80 and 81. Plan N-6 was rebuilt and once again exposed to the wave and swl conditions of Hydrograph A. Results of this repeat test were very similar to the first test with six dolosse displaced onto the revetment from the crown and beach-side dolos armor areas. After-test Photos 82 and 83 show that the revetment armor stone and the breakwater's dolos armor on the sea-side slope had sustained only minor damage.

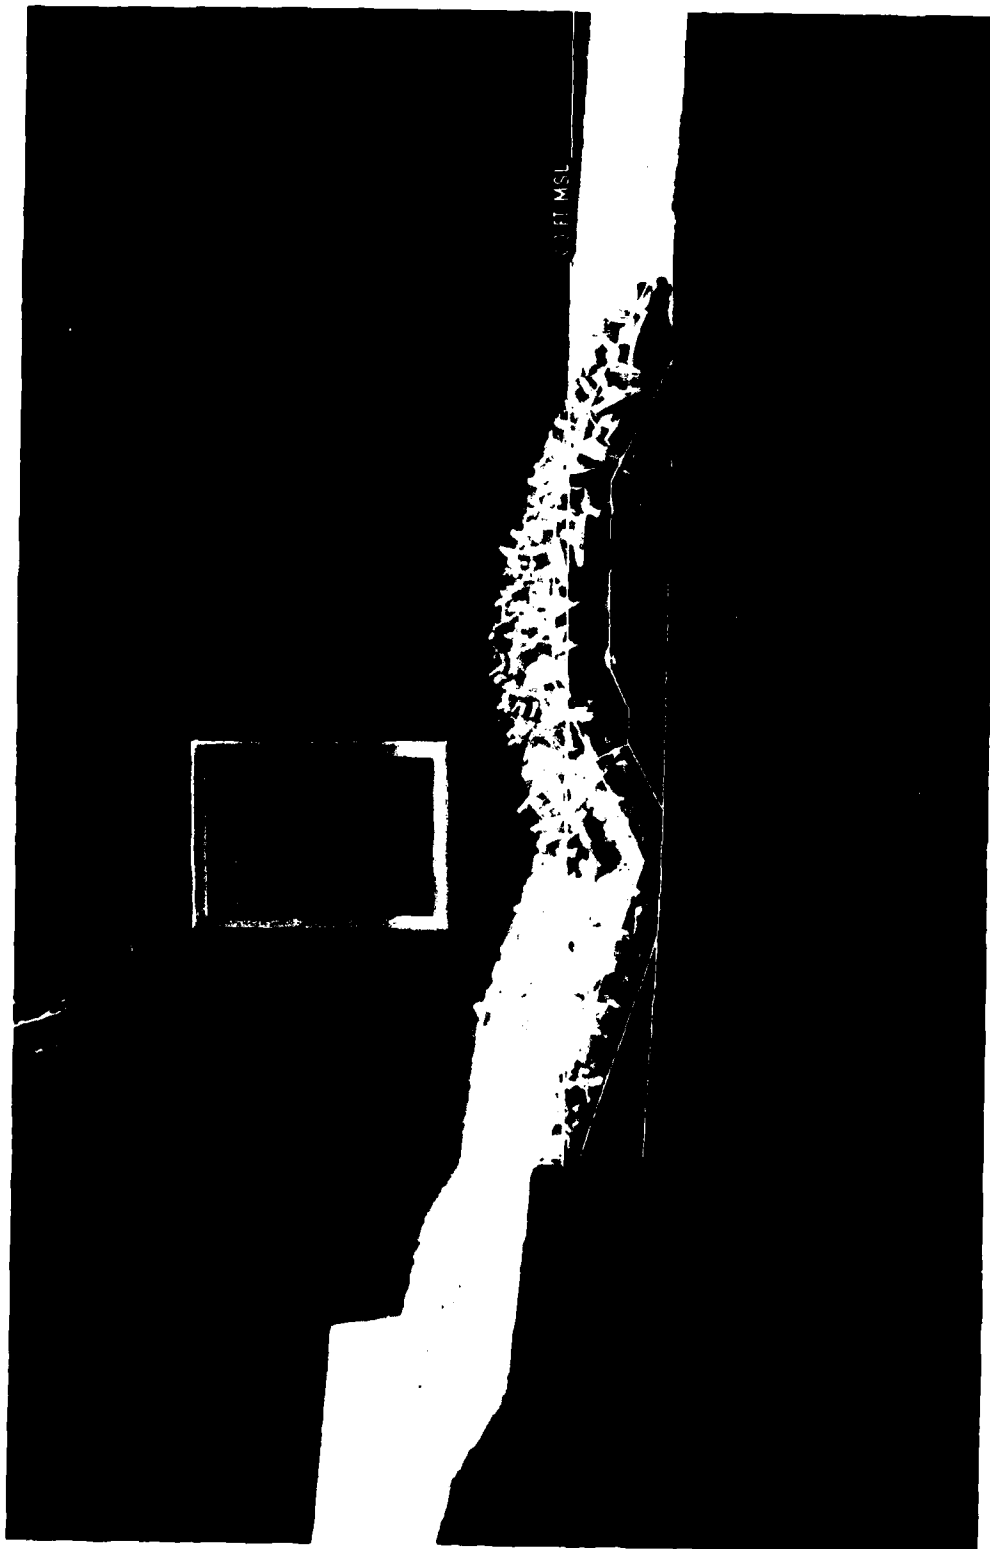
Photo 80. Side view of Plan N-6 after testing Hydrograph A (Plate 1 and Table 1),
1st test section

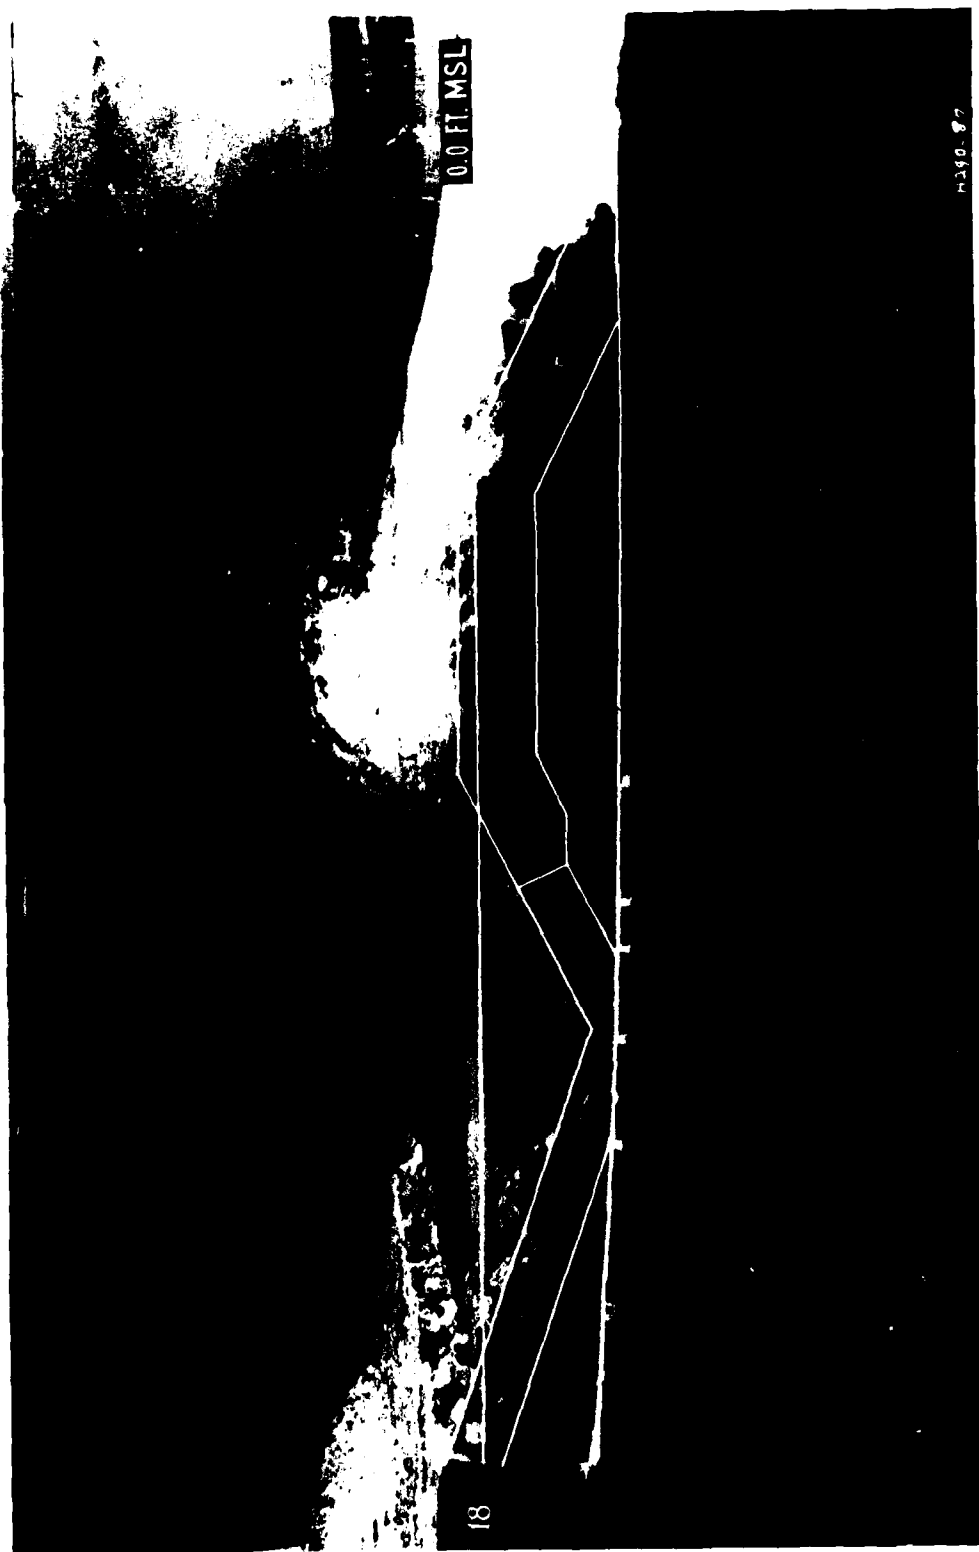
Photo 84. Side view of Plan N-6, 15.0-sec, 20.0-ft breaking wave at 0.0 swl,
Step 1 of Hydrograph A (Plate 1 and Table 1)

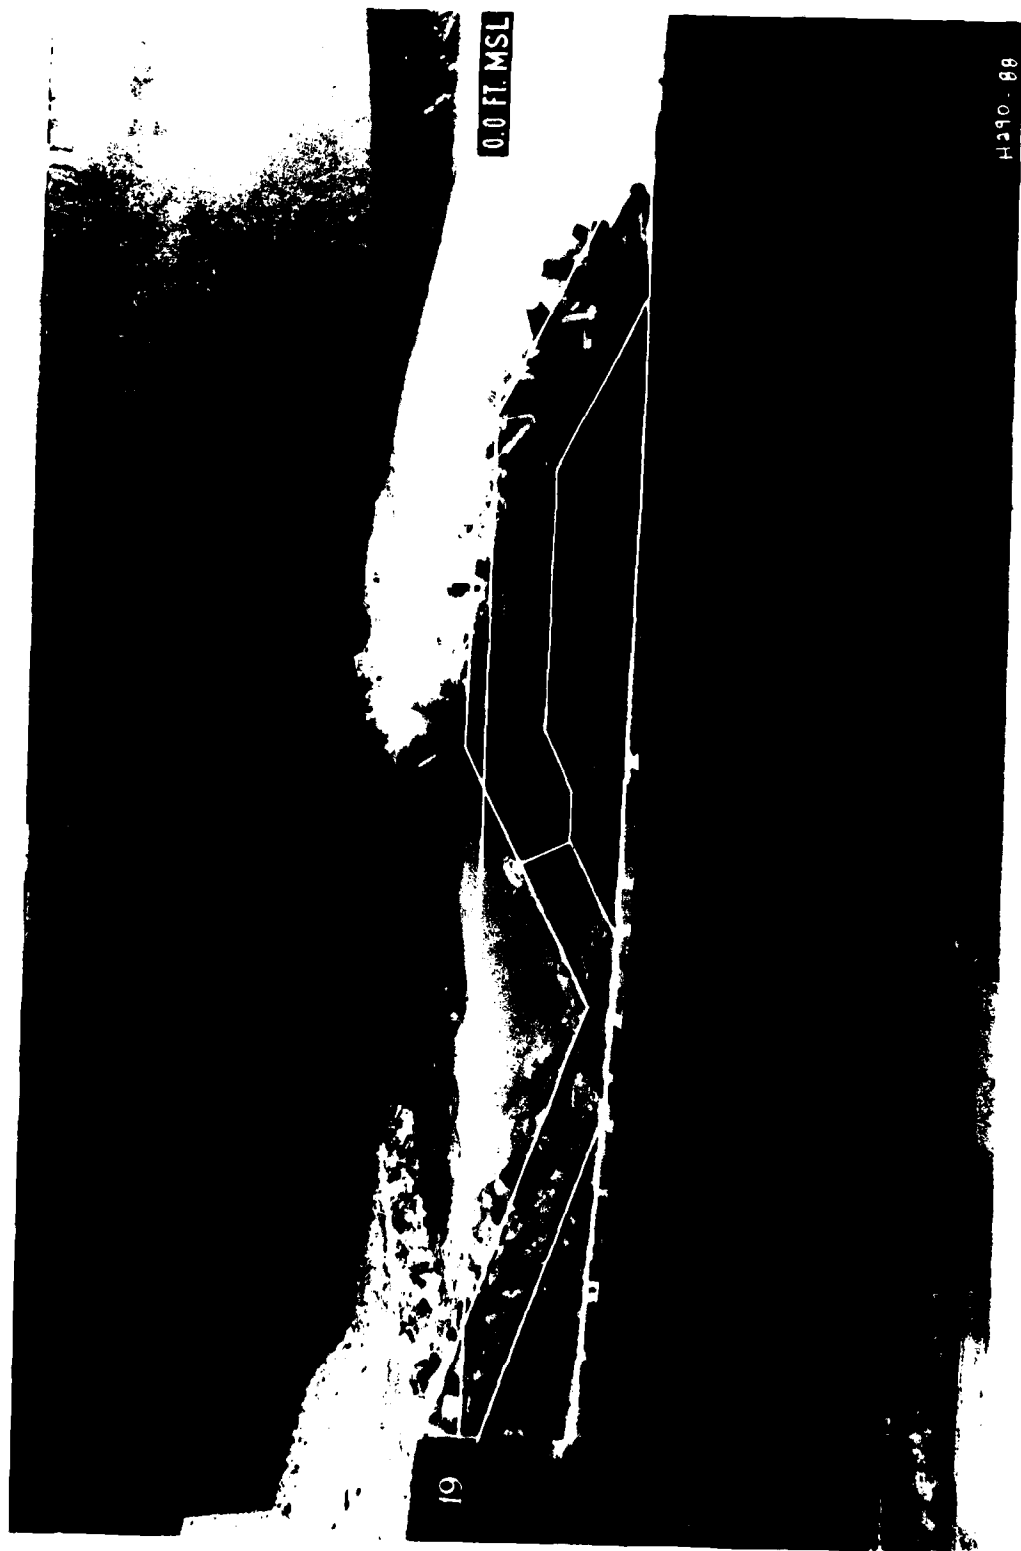
Photo 86. Side view of Plan N-6, 17.0-sec, 22.7-ft breaking wave at 0.0 swl,
Step 2 of Hydrograph A (Plate 1 and Table 1)

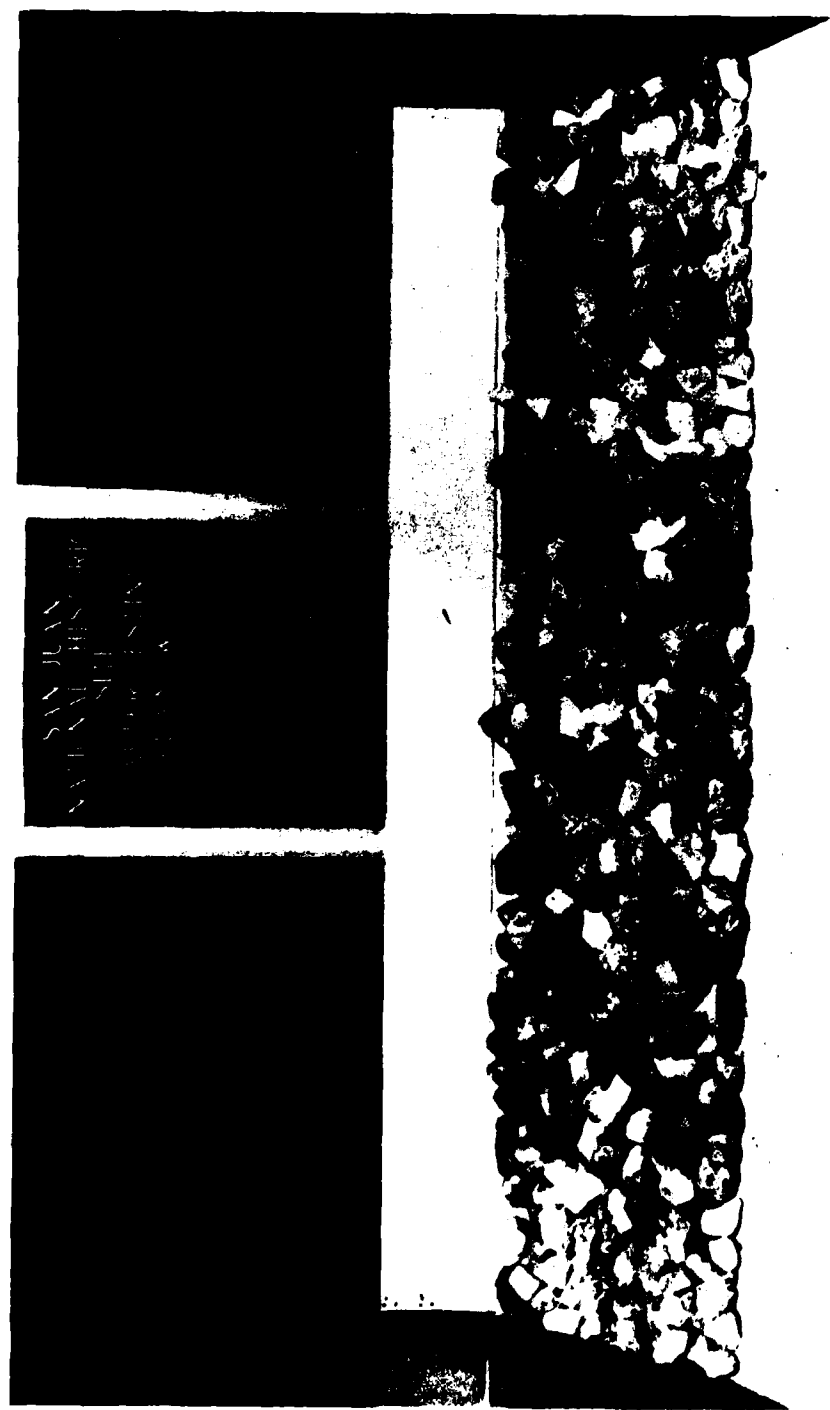
Photo 99. Sea-side view of Plan W-1 after testing Hydrograph B (Plate 2 and Table 2), 2nd test section

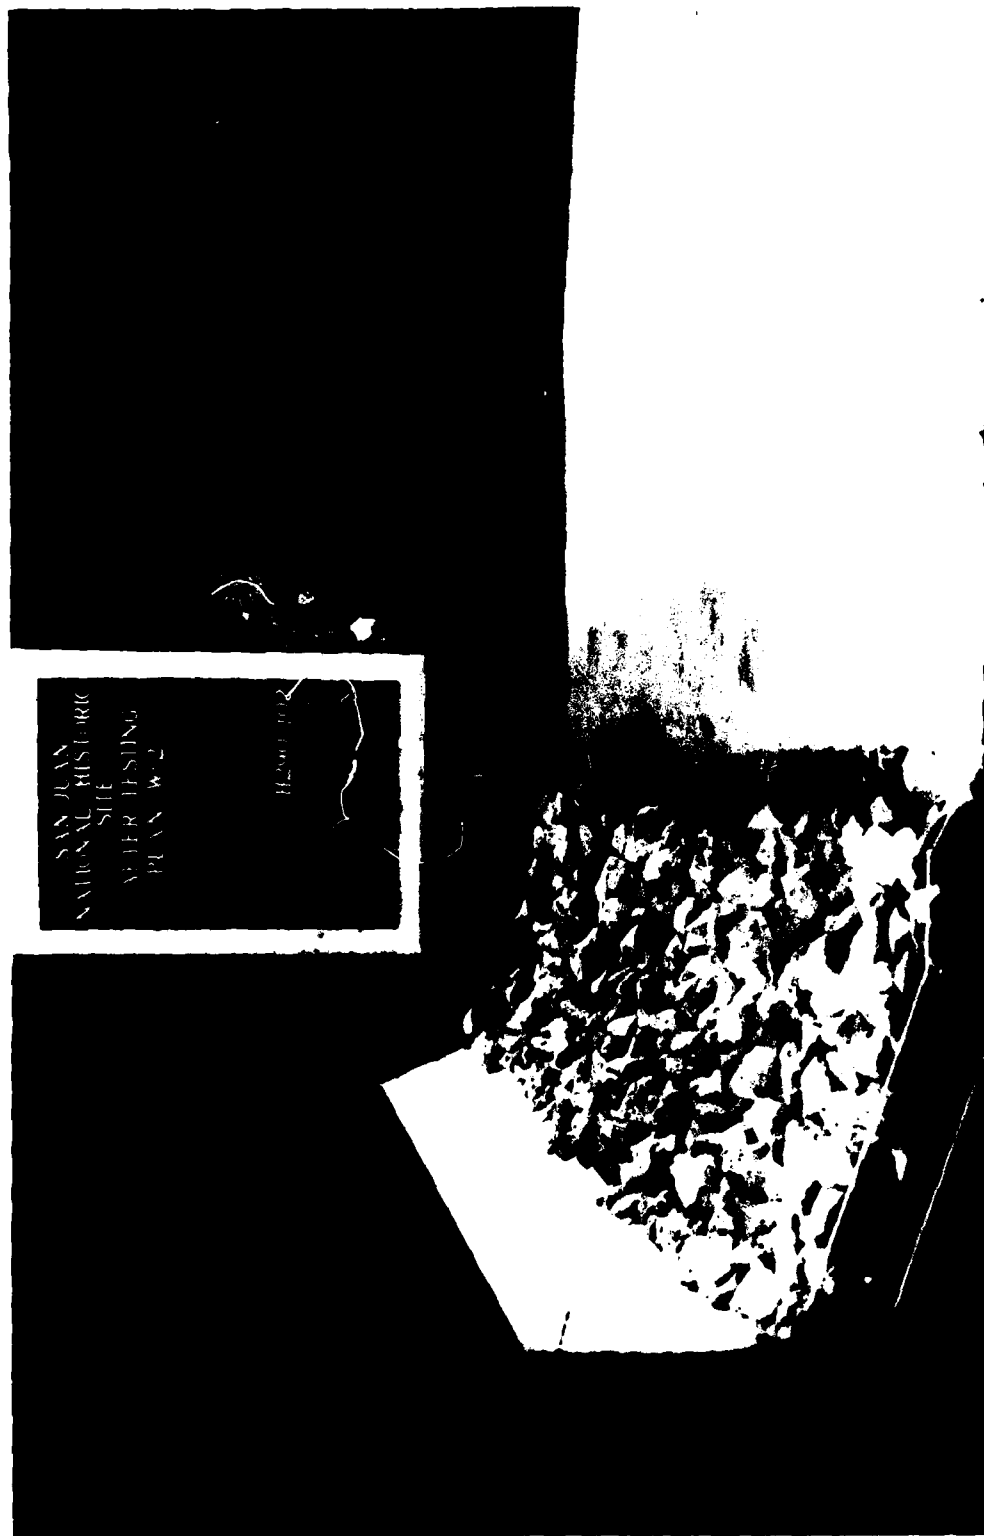
Photo 104. Side view of Plan W-2 after testing Hydrograph B (Plate 2 and Table 2), 2nd test section

46. Plan W-2. In an effort to optimize the design of the unprotected west revetment, tests were initiated on Plan W-2 (Plate 16 and Photos 100 and 101). The core and armor-stone weights were reduced to 700 and 7,000 lb, respectively. A two-layer, randomly placed armor-stone protection was used; and the overall size and shape of Plan W-2 were identical to Plan W-1. Exposure of Plan W-2 to the design conditions of Hydrograph B resulted in only minor spot damage along the revetment crown. As shown in after-test Photos 102 and 103, the remainder of the structure showed no obvious damage. Plan W-2 was rebuilt and exposed to the wave and swl conditions of Hydrograph B once again. During the repeat testing, Plan W-2 accrued a similar amount of spot damage to the revetment crown as had occurred during the initial test. Photos 104 and 105 show the condition of the revetment at the conclusion of the repeat test.
